GEOLOGIC CONTROLS ON COMPLEX SLOPE DISPLACEMENT AT THE PITCH RECLAMATION PROJECT

James A. Cremeens, Senior Engineer

Agapito Associates, Inc., 715 Horizon Drive, Suite 340, Grand Junction, CO 81506

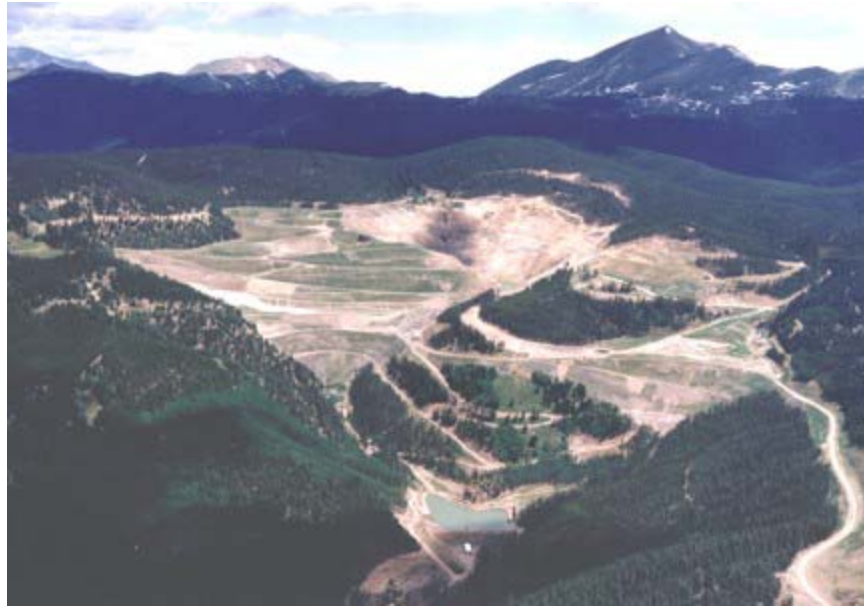
The North Pit currently extends from a maximum elevation of about 10,900 ft (3323 m) above mean sea level (amsl) at the east wall, to the level of the North Pit Lake at about 10,320 ft (3146 m) amsl. The North Pit has a maximum length of about 1200 ft (366 m) and a maximum width of about 1000 ft (305 m). It is comprised of the east wall, north wall, south wall, west wall, and the northeast corner. A shallow pit lake (North Pit Lake) currently occupies the bottom of the North Pit. Figure 1 is a photograph of the North Pit.

Figure 1. Photograph of North Pit looking north.

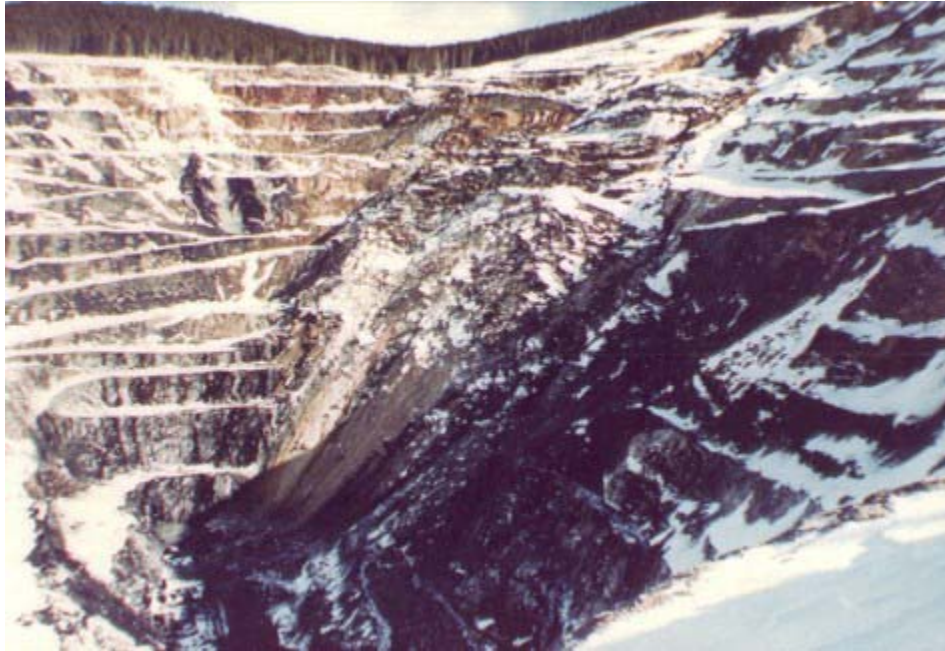
The year 1983 was a climatological anomaly, related to the El Niño weather phenomenon. The combination of warm fall temperatures (that caused the ground to remain unfrozen late into the year, enhancing infiltration), heavy winter snowpack, early and rapid snow melt and increased rainfall, resulted in optimum conditions for reducing shear strengths of slope materials in response to elevated pore water pressures. Slope displacement velocities reacted quickly to the increased infiltration of surface water and rising ground-water levels. On March 7, 1983, the slope displacement rates reached a non-recoverable velocity in the northeast corner of the North Pit and continued to increase until slope failure took place on March 13 and 14, 1983.

Figure 4. Northeast corner slope failure — March 1983.

developed tension cracks prior to the March 1983 event. The March 1983 slope failure in the northeast corner of the east wall resulted in about 60 ft (18 m) of vertical displacement at the headscarp. The slope failure mass appears to have originated primarily above the 10,600 bench, which traverses the North Pit at about mid-pit height. Large-scale, rapid slope failure was limited to the northeast corner of the North Pit, although headscarp development and tension cracking occurred throughout the Upper Block. The geometries of the shear surfaces of the northeast corner failures are characteristic of other slope failures in the weathered pegmatite at the site. These are characteristically circular in profile near the headscarp and roughly linear with little or no curvature at the toe.

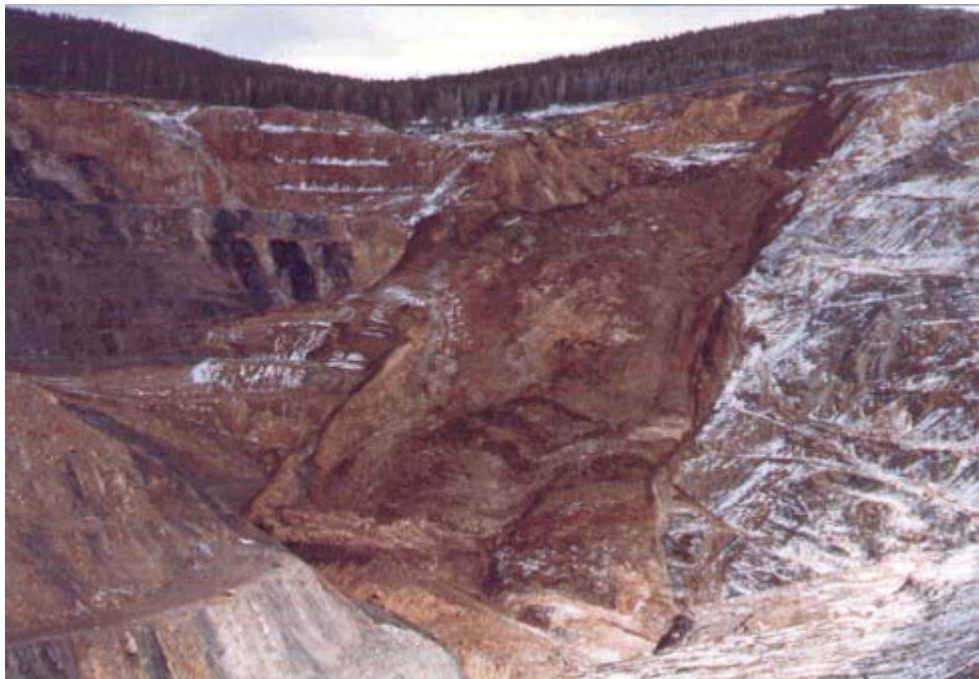
Figure 5. Northeast corner slope failure — October 1983.

As the North Pit slopes advanced north due to mining, following the March 1983 slope failure in the northeast corner of the North Pit, surveys of slope monitoring points revealed that all of the North Pit monitoring points were accelerating. The October 1983 northeast corner failure occurred in the same area as the March 1983 northeast corner slope failure, but progressed farther up the slope. The October event involved about twice the volume of the March event. The following account, quoted from the Homestake, October 1983, Monthly Report provides a dramatic account of the slope failure.

The October 1983 northeast corner failure completely filled the north end of the North Pit. The North Pit Lake began forming immediately after the slope failure. Displacement at the headscarp appears, based on photographic evidence, to have roughly doubled in magnitude to a total vertical displacement of about 120 ft (37 m).

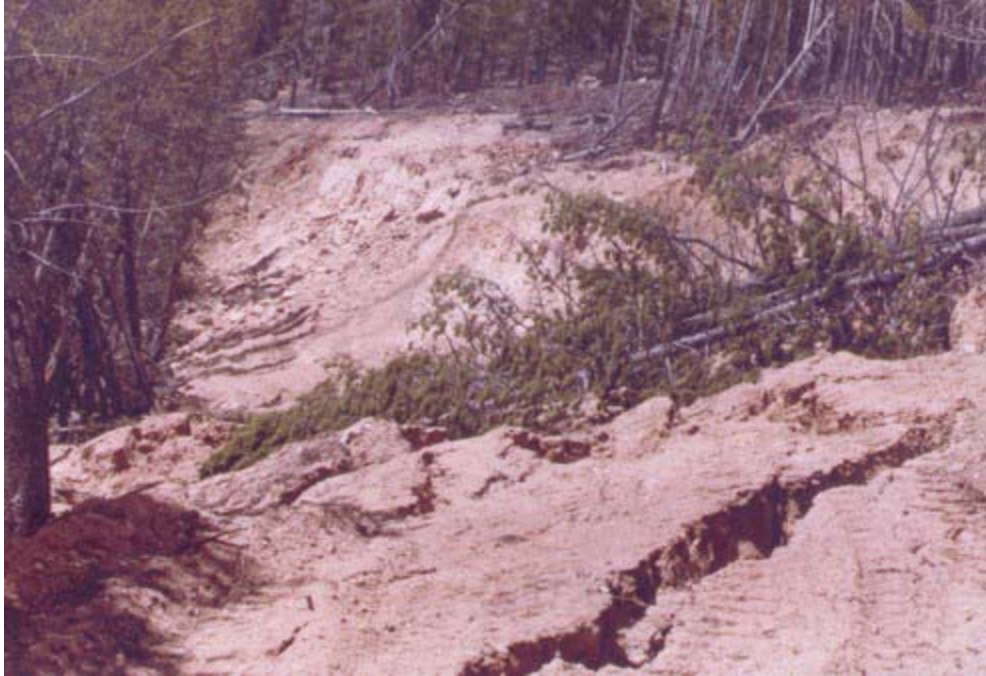
Figure 6 is a Homestake photograph of the headscarp taken after the March 1983 event. Figure 7 is a photograph from a similar perspective that was taken after the October 1983 event. Comparison of these photographs reveals the magnitude of displacement at the headscarp initiated by the two 1983 slope failures.

Figure 6. East wall headscarp following the March 1983 northeast corner slope failure.

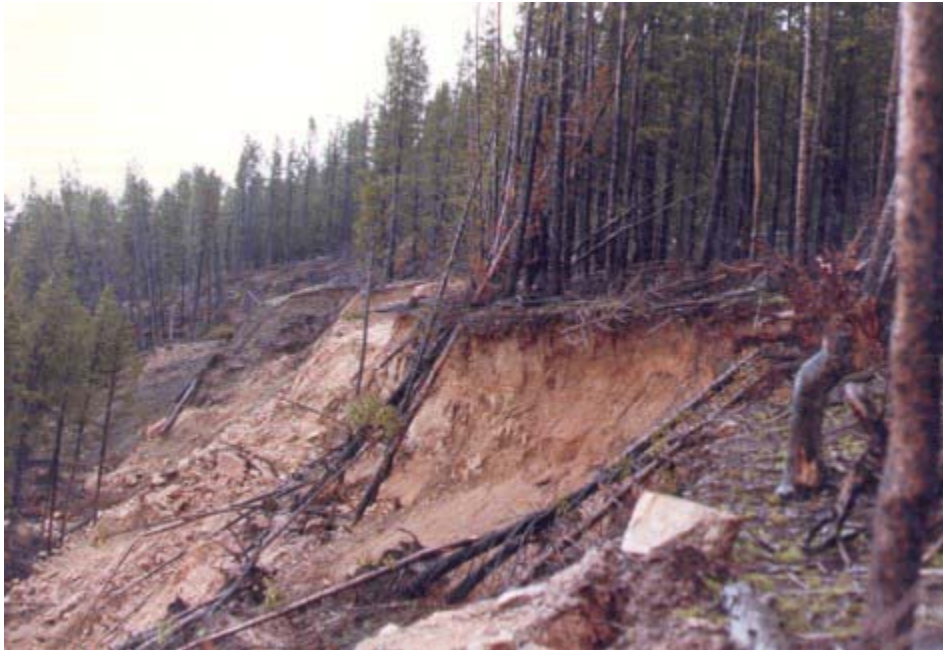
Figure 7. East wall headscarp following the October 1983 northeast corner slope failure.

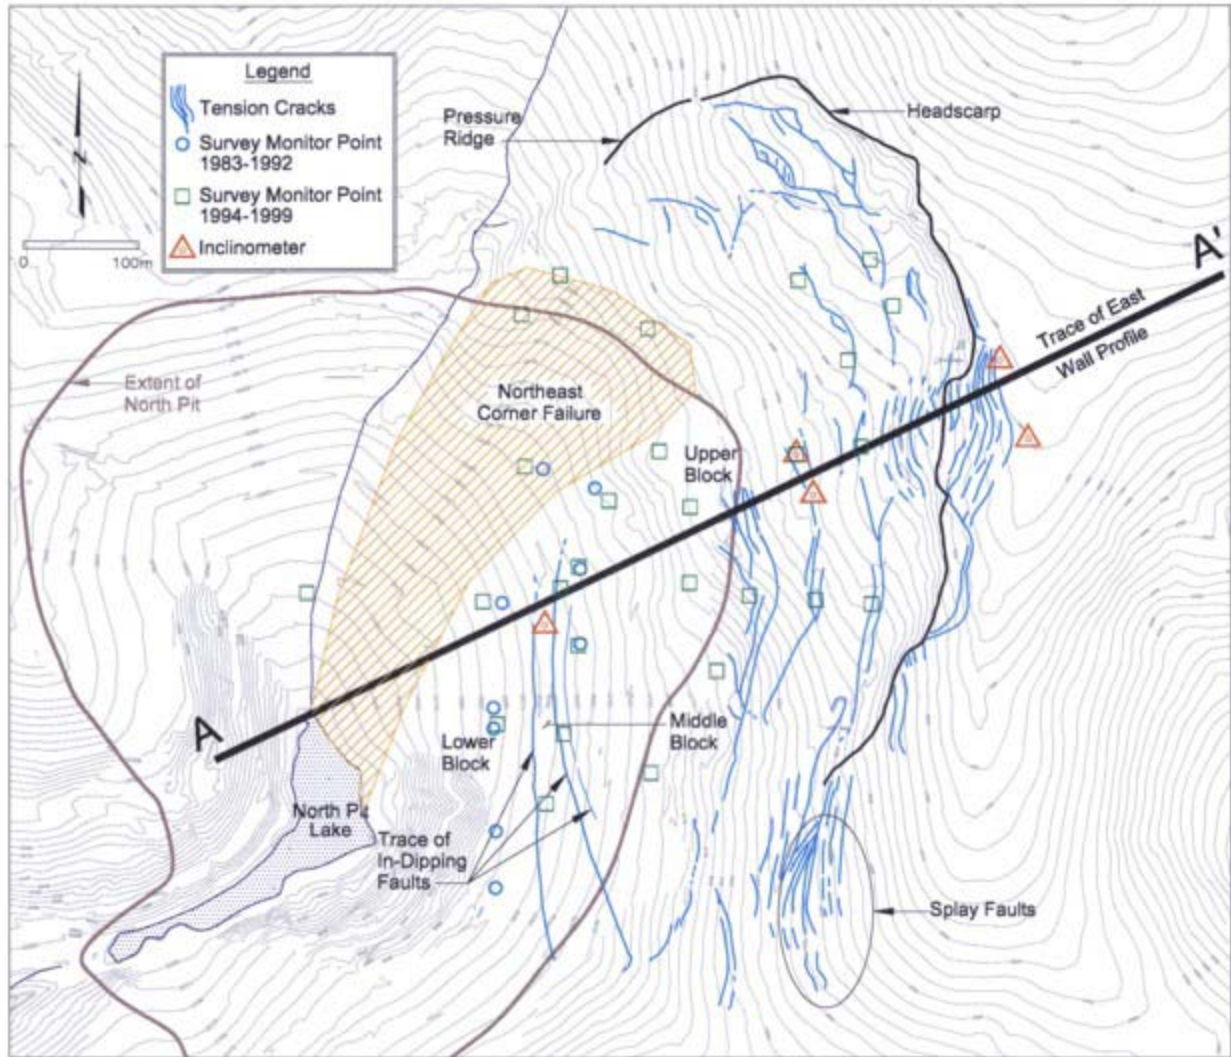
Figure 8 is a map of the North Pit, showing the northeast corner pit failure locations, the Upper, Middle, and Lower Blocks, and other components of the east wall of the North Pit. Figure 9 is a modeled pre-displacement profile through the most critical section of the east wall. Figure 10 is a modeled post-displacement profile showing bulging at the Lower Block, rotation of the Middle Block, and translation of the Upper Block.

Figure 8. Map of the North Pit showing east wall components.

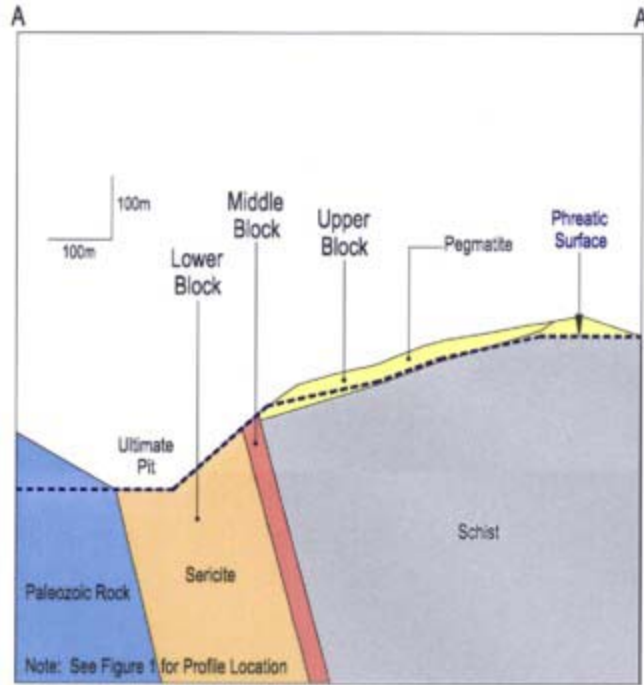
Figure 9. Pre-displacement geotechnical model profile.

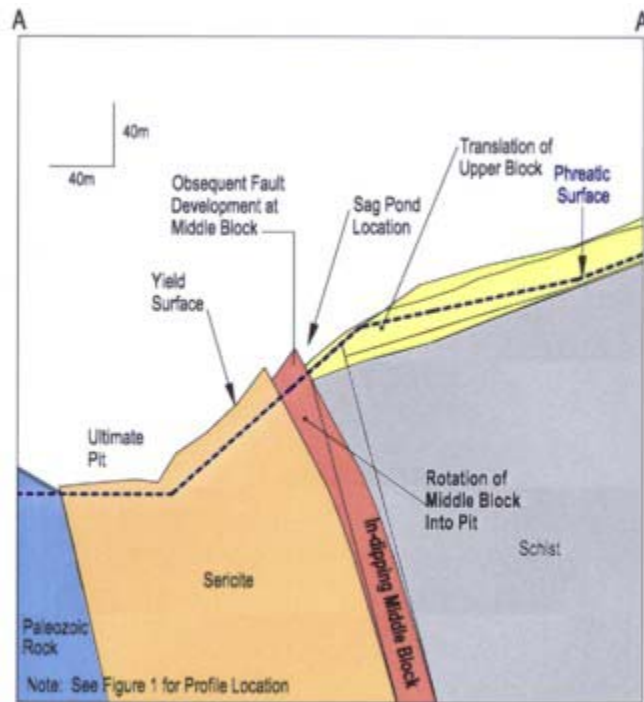
Figure 10. Post-displacement geotechnical model profile — deformation highly exaggerated.
