Preprint 02-113

UNDERSTANDING AND SOLVING ROOF CONTROL PROBLEMS IN STONE MINES

F.S. Kendorski
Agapito Assoc, Inc
Lombard, IL

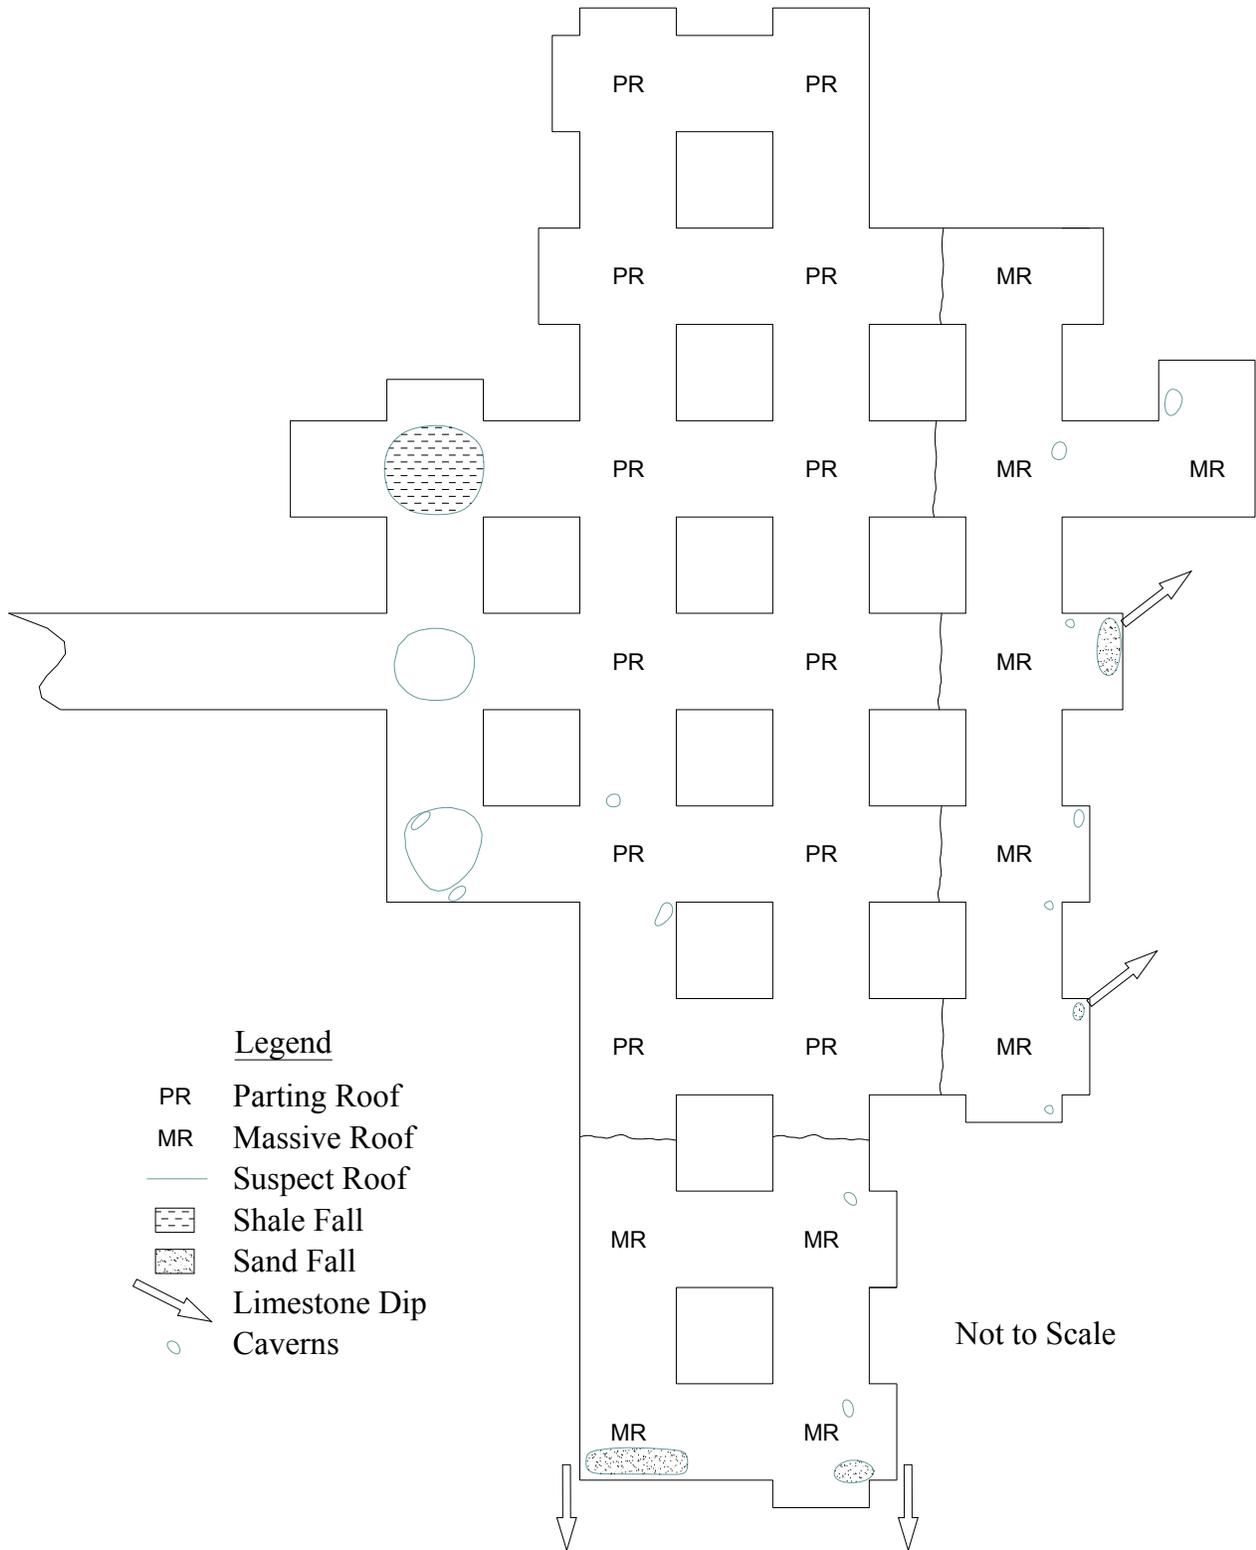
A roof conditions map of a stone mine is shown in Figure 1, where a simple system of roof horizon type nomenclature has been developed and found to be effective. By studying a roof conditions map, patterns can begin to emerge which help explain the behavior of the roof.

Figure 1. Sample Mine Roof Characteristics Map

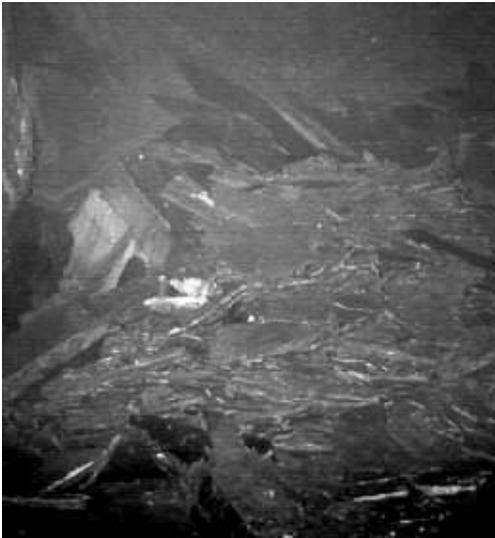
In the mine shown in the roof map figure, large roof falls (such as shown in Figure 2) extending over 20 ft into the roof occurred, causing serious concerns. After securing the immediate roof fall area, examination of borehole logs, the roof fall area, and the mine roof throughout the mine, it was discovered that the limestone that was picked for the roof horizon, which was generally at least 5-ft thick, had thinned to a few inches in a local area. Upon detailed roof probing and mapping, the mine operators and consultant realized that the limestone that formed the good roof, in one local area where the large fall occurred, had been eroded away by a paleo-channel after it was deposited and replaced by very weak shale. Recognizing the limited extent of such a roof condition, and that the paleo-channel's course could be mapped by probing the roof, a roof control strategy of noting the roof character when drilling roof bolt holes and pattern bolting installed as early in the mining cycle as practicable proved effective.

Figure 2. Large Roof Fall from Paleo-Channel

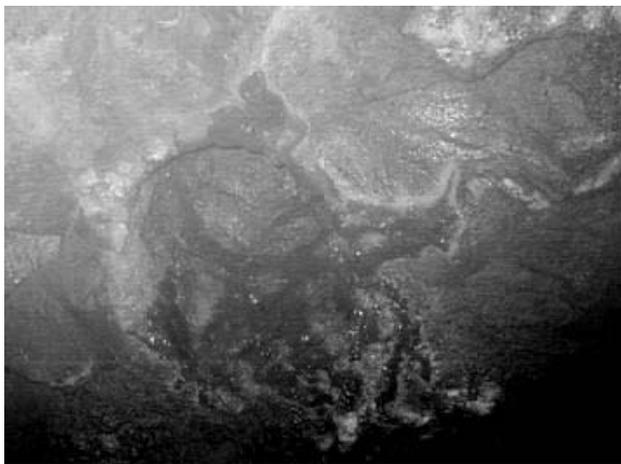
At another mine the roof was very good, but a good clean parting was seldom available at the desired roof horizon, which was based on stone quality considerations. More careful blasting was necessary along with pattern rock bolting. Figure 3 shows this roof, along with a "cavern" that was revealed after blasting. Such karst solution features are not uncommon in this stone mine and are nuisances. The caverns are found filled with water and mud, which rushes out after blasting. The caverns do not extend into the limestone being mined, but occur only in the roof horizon formation. For safety precaution reasons, a barricade is placed around the base of each cavern to keep personnel and equipment from being directly underneath in case more mud and water fall out, which has not yet happened.

Figure 3. Uneven and Karst Feature Roof

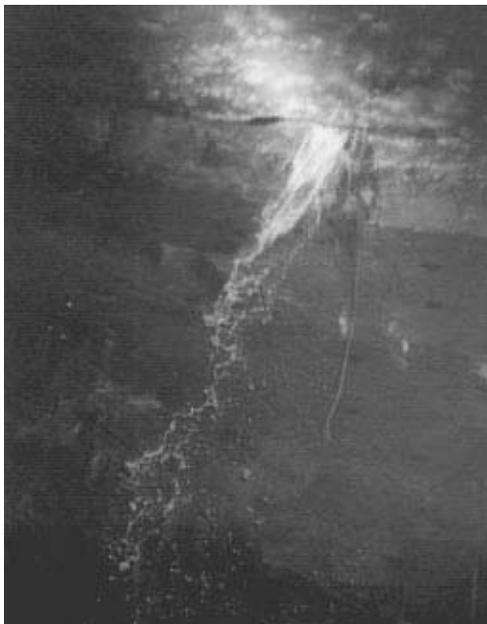
In a stone mine in the Midwest, water was a nuisance and could be quite a spectacular feature as the water gushed out of the roof from open solution-widened joints, as shown in Figure 4. However, after completing a detailed map of roof characteristics, it was realized that water played more than just a nuisance role. The mine is relatively shallow and is developed under several bedrock and sand and gravel aquifers. Roof problems had been occurring when the roof horizon broke back from a usual very good, massive limestone roof (such as shown in Figure 5), to a roof characterized by angular jointing and strata compaction shears (as shown in Figure 6). The roof shown in Figure 6 was more difficult to control, with the angled joints and shears leading to relatively small fallouts. The roof would sometimes break even higher into the overlying strata, forming a very uneven, angular surface, which was usually shaley and weak (as shown in Figure 7).

Figure 4. Water Emanating from Open Joint

failure to a more-angular and less-competent strata more difficult to reinforce. With this knowledge, the mine can anticipate the effect of water and provide drain holes in the roof. Also, the mine adopted hemispherical roof bolt washers that helped the rock bolts hold the roof better in the weaker angular-feature roof.

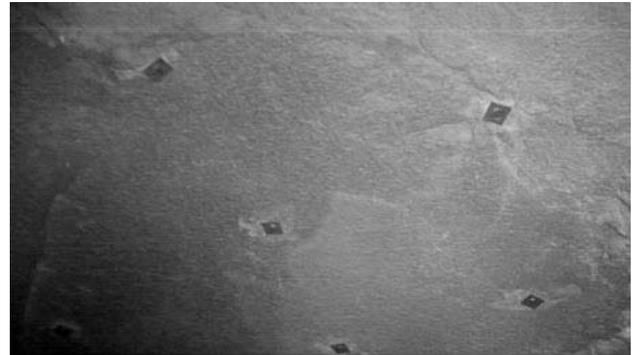
Figure 5. Good, Sound, Massive Limestone Roof

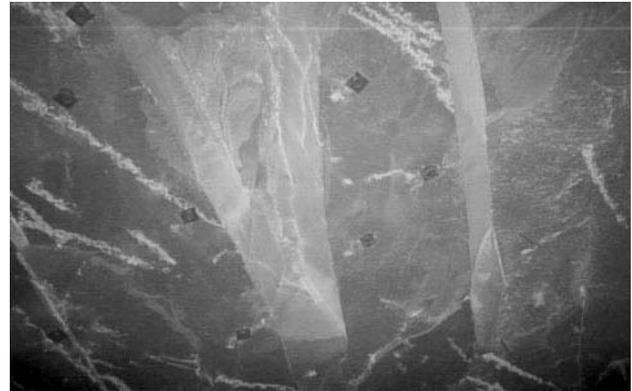
Figure 6. Roof with Angled Joints and Shears

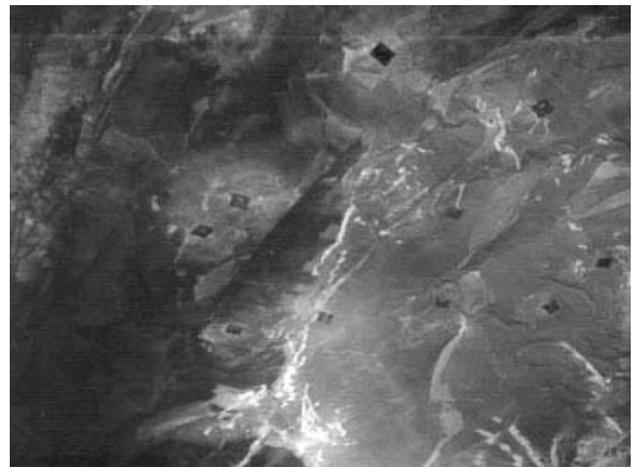
Figure 7. Very Uneven Roof with Many Angled Joints and Shears

When the different roof types were mapped out, it was realized that the higher-breaking angular type of roof only occurred in mine areas away from the surface quarry wall that was the mine's entrance portals. As it happened, the ground-water flow in the region was from a direction away from the quarry wall where the portals were located. The surface quarry was intercepting the ground water before it reached the mine. However, the mine extended beyond the quarry surface "footprint," laterally perpendicular to the ground-water flow direction. Where the mine extended beyond the quarry footprint, the roof exhibited the higher-breaking and angular features. Furthermore, as the mine extended farther away in the direction of the ground-water flow, the higher-breaking and angular features reappeared. In this more distant mine area, the ground water was able to begin to flow around the surface quarry.

The ground water, when not intercepted by the surface quarry, appeared to be pressurizing the roof strata leading to roof

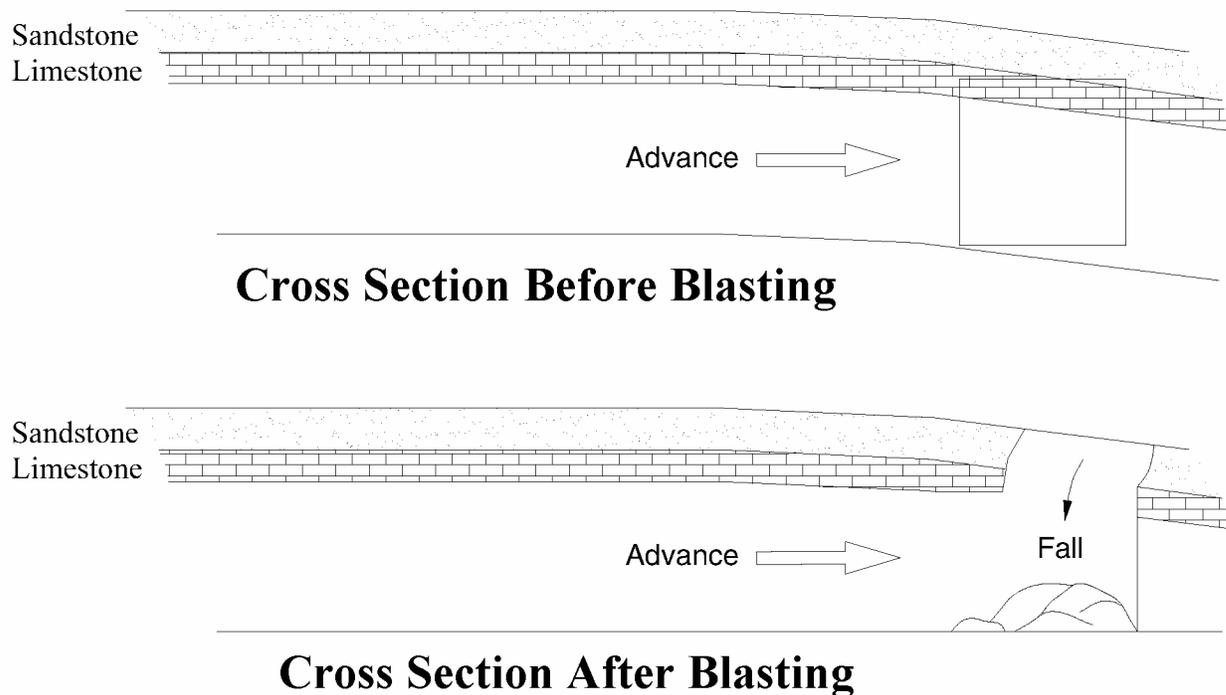
A stone mine was developed in a high-quality limestone, with a good roof of about five feet of the same limestone left in place. There was no clear, clean-breaking parting to drill and blast to form a consistent roof. To keep the mine on grade with no roof marker, the mine used high-quality laser survey sighting to align heading direction and grade in the nearly flat-lying limestone. At the perimeter of the expanding mine, several roof falls occurred and exposed a thin limestone roof that fell out, allowing a run of a soft wet friable sandstone from above. Carefully mapping the mine, and re-plotting original borehole stratigraphic data, it was discovered that the mine limestone horizon was entering a gentle monocline or limb of an anticline

(as shown in Figure 8). When the mine elevation was kept at a consistent level grade, the mine roof horizon moved stratigraphically up into the weak sandstone. With no good stratigraphic marker bed, the mine had inadvertently developed into a weak roof condition. The mine management had the unpleasant dilemma of accepting increasingly poorer roof conditions and dilution, or substantially increased pumping and water nuisance as the expanding mine perimeter became increasingly deeper than the decline bottom if the mine horizon stayed in the target limestone level.

Figure 8. Effect of Formation Dip on Consistent Level Mine Roof
