# 25th International Conference on Ground Control in Mining

## ANALYTICAL INVESTIGATION OF SHAFT DAMAGES AT WEST ELK MINE

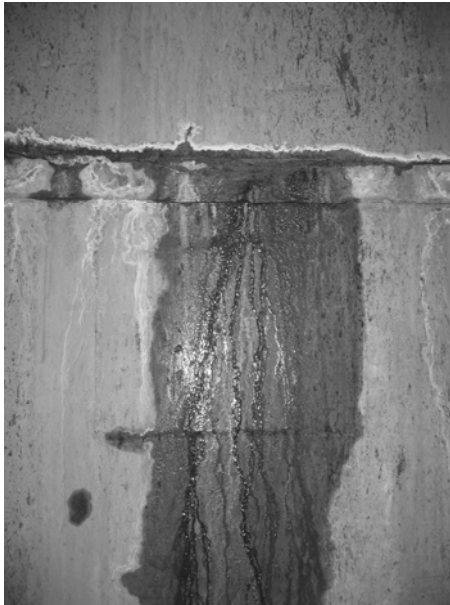
The water seepage at 100 ft below the collar of Shaft #1 is through a cold joint on the east side of the shaft. At the time of

the inspection, the quantity of water inflow was enough to wet the inside of the lining at the points of ingress, but totally evaporated before flowing more than 25 ft down the shaft (Figure 2).

Figure 2. Shaft #1—Water Ingress at 100 ft Below the Collar

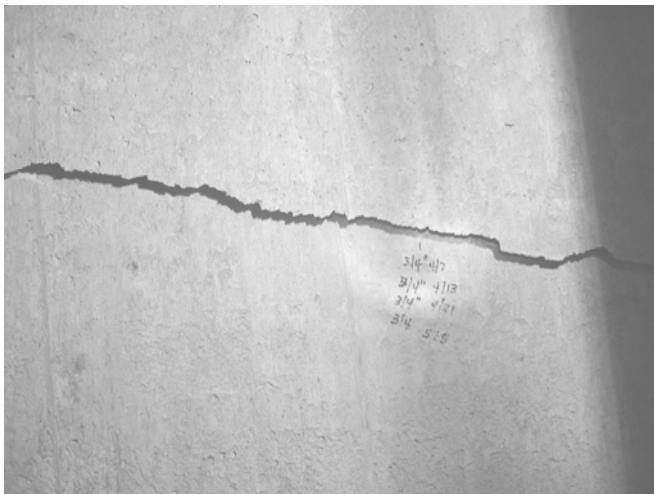
At 227 ft below the collar of Shaft #1, damage to the shaft liner had an irregular failure pattern. The main shear failure was generally in a horizontal plane, but meandered several feet in elevation as it continued around the perimeter of the eastern compartment. As shown in Figure 3a, the maximum offset in this horizontal failure plane was 0.75 inches in the east-southeast side of the shaft liner. The shaft liner below the horizontal failure had moved east relative to the shaft liner above the failure horizon. This horizontal cracking continued in both directions around the shaft, at least to the 1-ft-thick concrete shaft partition where the horizontal offset is zero (Figure 3b). At several locations in the east compartment, vertical cracks branched off the main horizontal

Figure 3a. Shaft #1—Maximum Offset from Shear Failure at 227 ft Below the Collar

The rock mass elastic properties reduction factor was calibrated to reproduce the amount of ground deformation associated with the shear offset in Shaft #1 after Panel 23 mining. AAI estimates that 2.5 to 3.5 inches of total ground movement was required to cause the 0.75-inch offset in Shaft #1's concrete liner located approximately 227 ft below the collar. The total ground movement is expected to be greater than the shear displacement in the shaft liner because of the shaft liner panning and voids behind the panning absorbing a portion of the total ground movement.

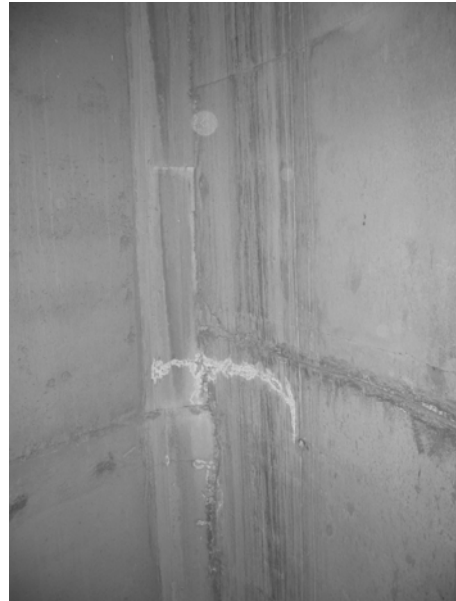
Figure 3b. Shaft #1—Horizontal Crack with Zero Offset at Patrician Wall 227 ft Below the Collar

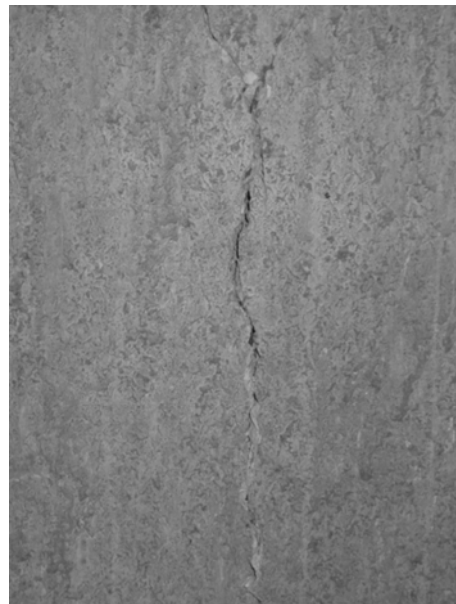
failure plane (Figure 3c). There was no relative displacement associated with the vertical cracks.

Figure 3c. Shaft #1—Vertical Crack Branching from the Main Horizontal Crack at 227 ft Below the Collar

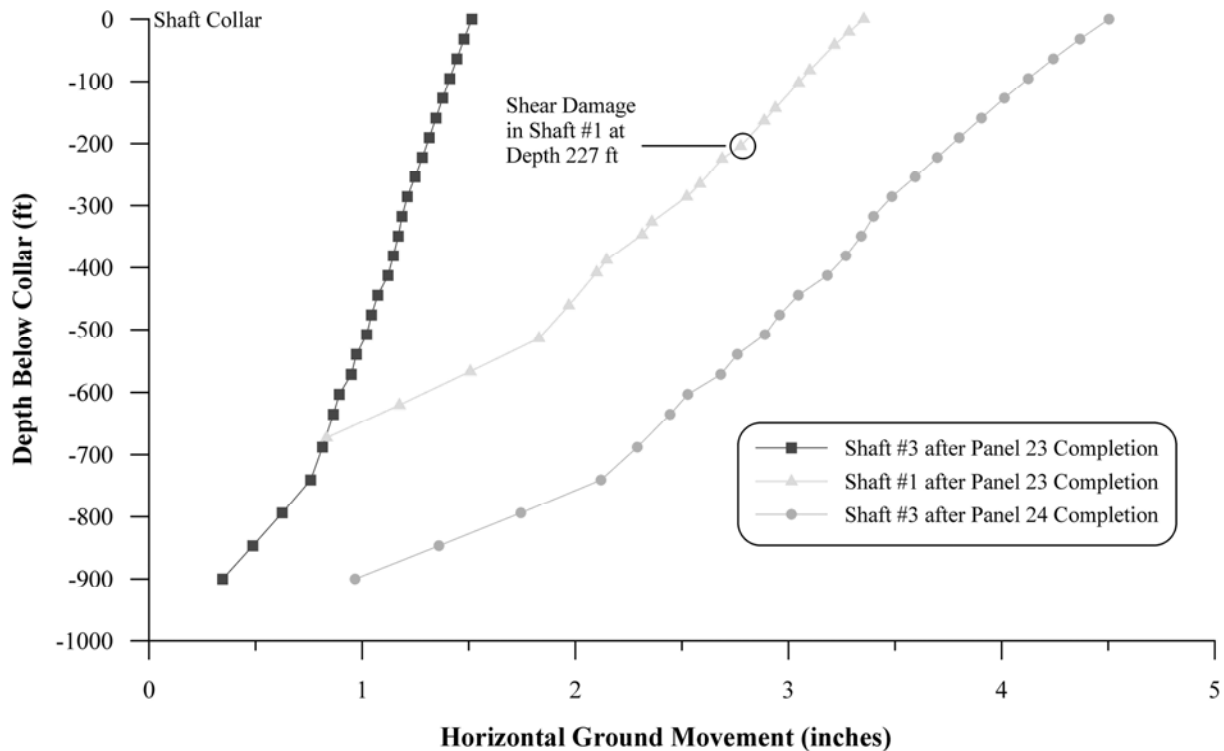
Figure 6 describes the modeled horizontal ground movement corresponding with stress relief at shafts #1 and #3. The figure illustrates total horizontal movement along the two shaft profiles at the end of Panel 23 and Panel 24 mining. Horizontal movement increases toward the surface because movement is cumulative of all effects below any horizon in the shaft. Movement at the shaft collar represents the cumulative movement of the entire overburden column.

Figure 6. Horizontal Ground Movement Along Shaft #1 and Shaft #3

surface. The model results in Figure 6 show that as much as 2.8 inches of shear-slip movement in response to Panel 23 mining was possible around Shaft #1 at the depth where liner damage was observed (227 ft depth). This corresponds with the scale of ground movement that is estimated to be necessary to close various construction-related voids around the shaft liner, crush the panning, and offsetting of the concrete liner by 0.75 inches. Results suggest that shafts #1 and #2 will experience only minor incremental movement as Panel 24 is mined.

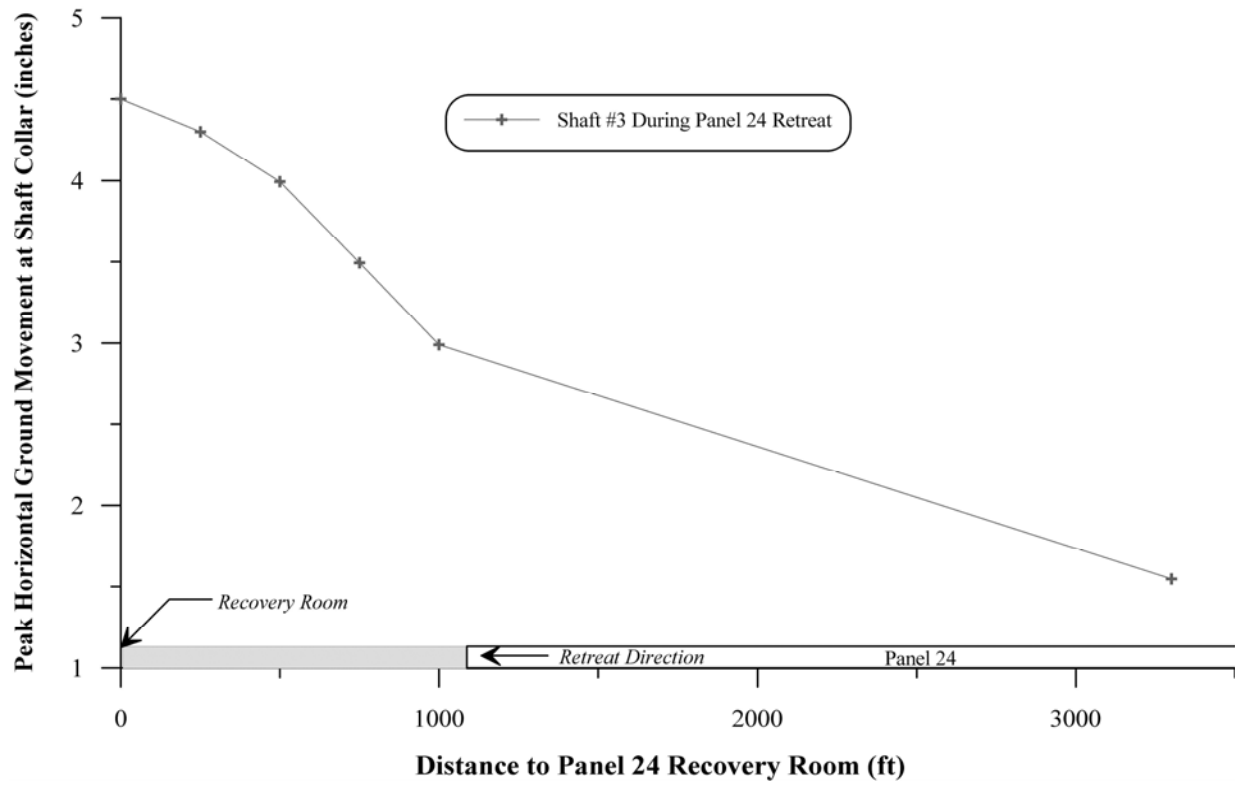
Figure 7 compares peak ground movement at the Shaft #3 collar with the position of the Panel 24 longwall face. Model results show that the rate of movement accelerates as the face approaches and that as much as 1.5 inches of incremental movement is likely to occur during the last 1,000 ft of retreat. Implications are that significant stress relief around Shaft #3 is still possible during the final stages of the Panel 24 retreat in spite of substantial past mining in the area, and that ground strain is likely to be of sufficient magnitude to damage the concrete liner. The scale of damage, if any, depends upon the local geology, construction of the liner, and whether ground strain occurs gradually over the length of the shaft or if it causes differential shear movement consistent with the response in Shaft #1.

Figure 7. Horizontal Ground Movement at Shaft #3 Collar During Panel 24 Retreat
