Preprint 02-056

HORIZONTAL STRESSES AS INDICATORS OF ROOF STABILITY

**2002 SME Annual Meeting
Feb. 25 - 27, Phoenix, Arizona**

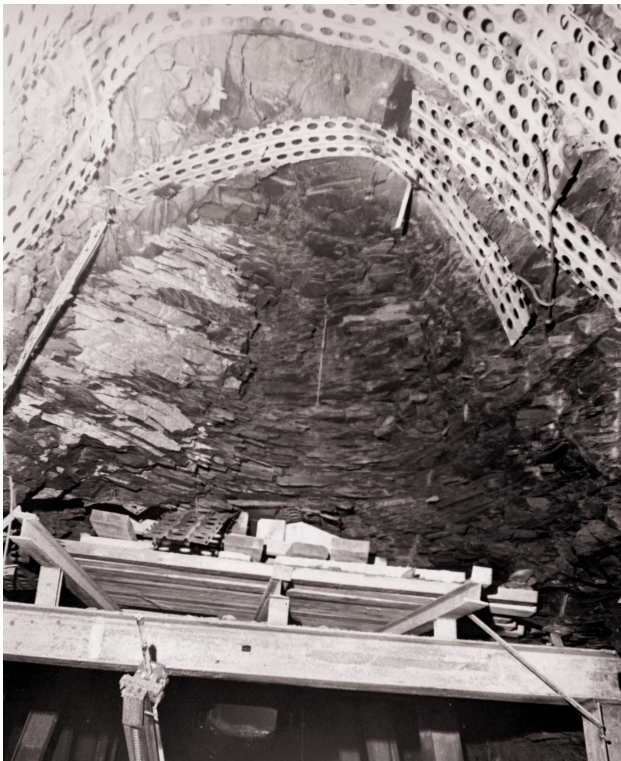
Figure 1. Dome of White Pine Roof Fall

The types of failure in both areas have been described in previous papers (Parker 1966, 1973; Aggson 1978a, 1978b). One of the most severe problems was the occurrence of high roof falls with little or no warning. These falls occurred in laminated (thin) strata and could be more than 6-m high by 45-m long. Aside from obvious safety issues, their impact to operations was major, especially if located in major travel/airways, conveyor belt entries, etc. Figures 1 and 2 show two such roof falls from both mining areas. In Figure 1, the fall occurred in a conveyor entry. The high arch and laminated strata are clearly seen. The fall was being cleaned up and the ground stabilized with steel sets, bolts, and mats. Figure 2 has been shown in previous papers and shows typical cutter failure in laminated strata and a high arch.

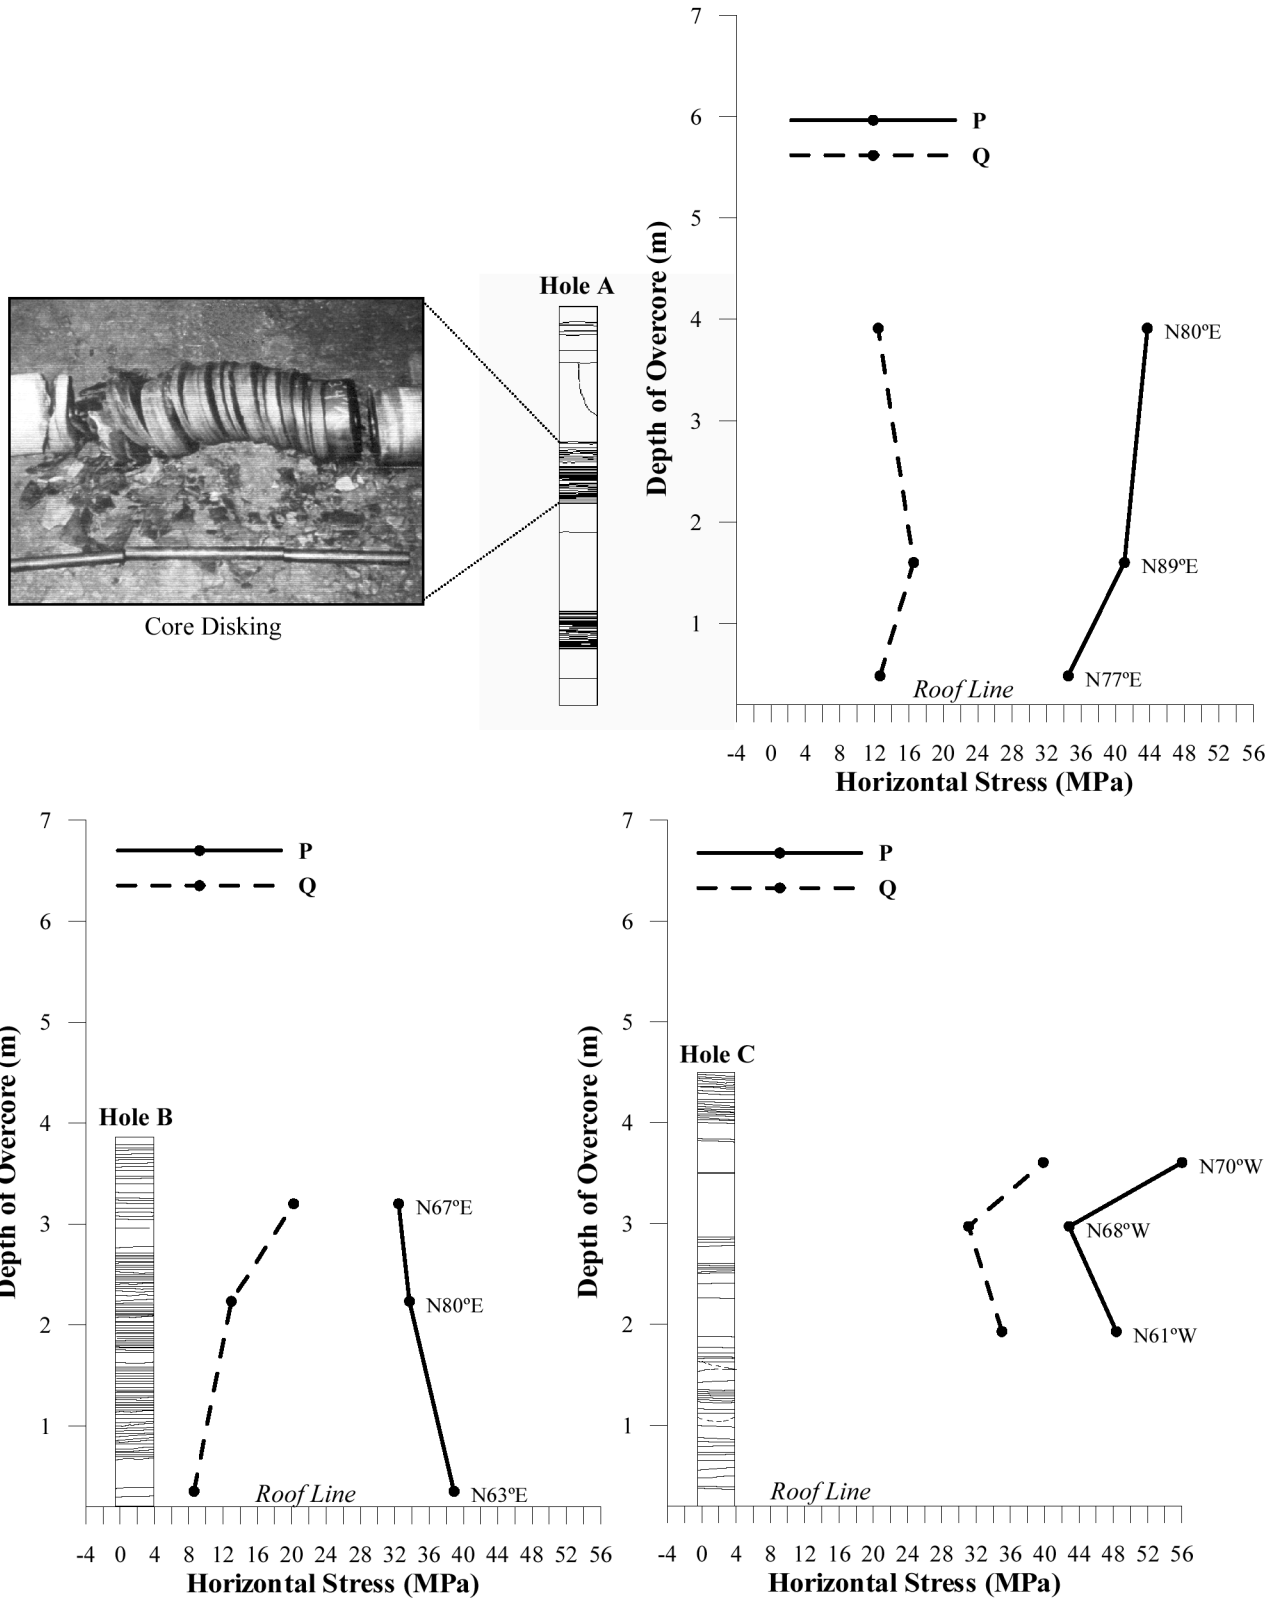
Figure 3. Roof Stress Profiles, White Pine Mine

Figure 3 shows the last three profiles taken in the White Pine Mine a few years before it was shut down, in great part due to ground control problems. Profiles A and B were taken at depths of 685 and 625 m, respectively, and at a distance of 8 km

from each other. Reasonably good agreement in magnitude and direction was obtained between the holes. P is on the order of 33 to 41 MPa, and Q is 9 to 20 MPa. Average direction of Q is N82°E in Hole A and N70°E in Hole B. Most of the previous measurements showed a northeast direction. The third profile (C), at a depth of 700 m and about one km from Profile B, shows higher stresses, with P varying from 43 to 56 MPa and Q from 31 to 40 MPa. A consistently different orientation, with P at N66°W, and small variation between measurements was obtained. The large difference in stress directions from most other holes was at first (hopefully) thought to be due to instrument or calculation error, but having found none, the “anomalous” direction was attributed to a nearby fault system and/or proximity to an abutment pillar (Agapito and Litsenberger 1993). P/vertical stress ratios varied from 2 to 3.

All the overcore logs showed considerable diskings, indicative of high stresses (Figure 3). In addition to the fracture logs, a core photograph from Hole A clearly shows diskings.

Three common profile shapes, due to different stress distributions, are illustrated in Figure 3. Profile A shows three stress distribution zones: (1) a zone of lower stresses near the roof line due to geologic discontinuities, stress, and blast-induced fracturing; (2) a zone of higher stresses due to effect of the opening; and (3) a zone with low or no disturbance, with stresses at or near pre-mining levels. In Profile B, Zone 2 occurs very near the roof line because the rock was a very competent, high modulus siltstone, with few discontinuities and fractures. Profile C shows mostly Zone 3 because measurements in the other two zones were not possible due to diskings.

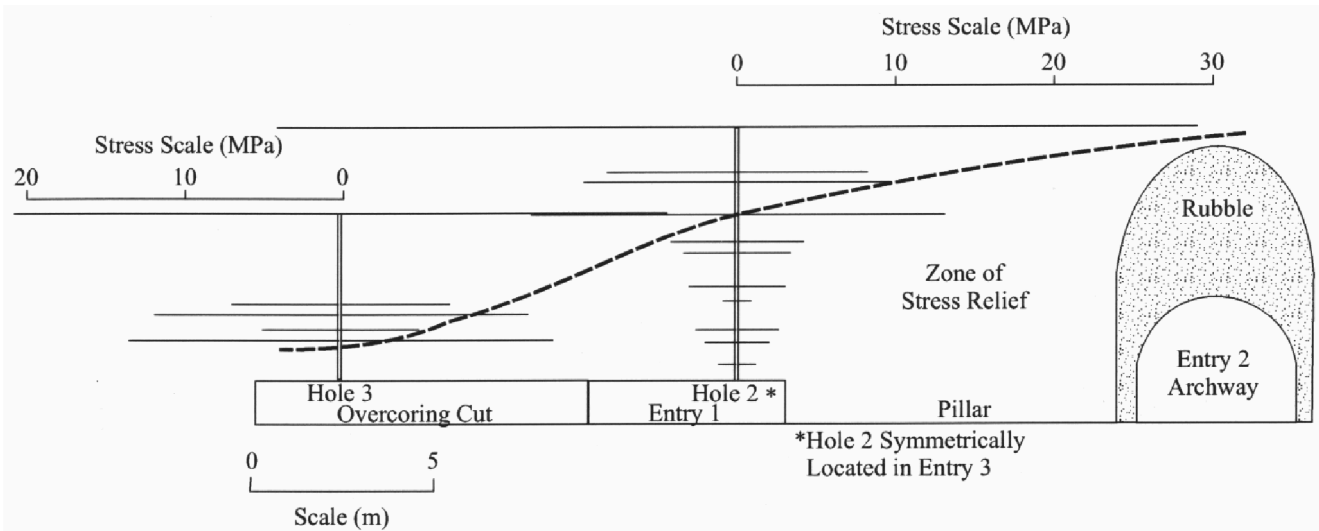
Figure 8. Illustration of Stress Shadow Generated by an Arched Entry, West Virginia Coal Mine

Horizontal stress measurements were used to verify the extent of a stress shadow (stress relief) area established by a central arched entry of a three-heading development in a West Virginia coal mine with extreme cutter problems (Aggson 1988). Cutters had been almost eliminated in the two adjacent headings after adoption of the central arched entry.

Figure 8 shows the stress shadow as much lower horizontal stress in Hole 2 as compared to Hole 3. The arch in the central Entry 2 disrupted the transmission of high horizontal stresses in the roof on Entry 1, thereby eliminating most of the ground control problems. The overcore measurement verified that the roofs of the outside entries were within the zone of stress relief created by the arch.

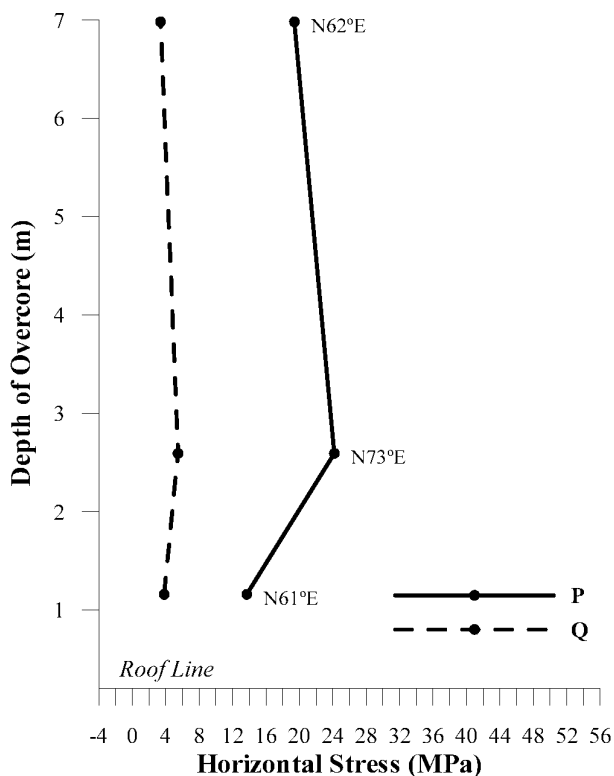
Figure 9. Roof Stress Profile Showing High Anisotropy, Colorado Coal Mine

Stress determinations in the North Fork Valley coal mines in western Colorado have shown the existence of high anisotropy in many measurements. Figure 9 shows a horizontal stress profile from one of these mines. The measurements were taken in a gateroad at a depth of 625 m before retreat longwall mining began. The profile shows the three previously discussed stress distribution zones; a lower P of 14 MPa (Zone 1), increasing to a maximum 24 MPa (Zone 2), and then decreasing to 19 MPa (Zone 3). The average P/Q (anisotropy) ratio is 4.6. P is nearly parallel to strike-slip faults encountered in the mine. These faults seemed to have been formed by northeast oriented forces caused by the intrusion of a pluton into the sedimentary strata. The faults in the mine have little or no surface expression, indicating that they were initiated at depth as the pluton penetrated the sediments. Vertical stresses were also measured and are identical to the calculated overburden stresses.

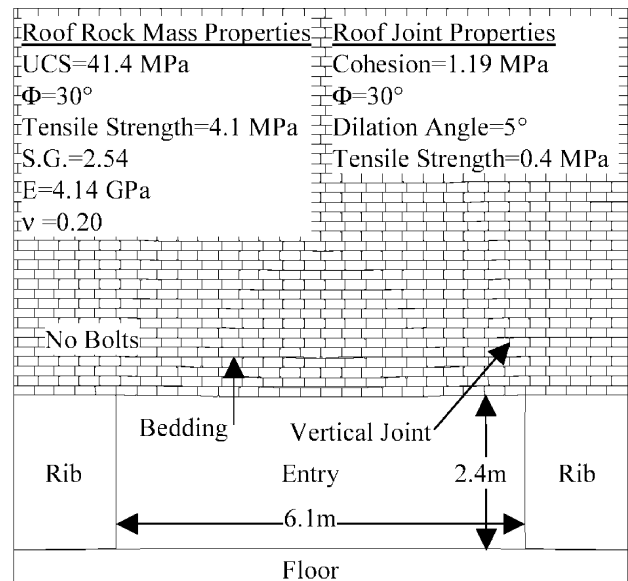
Figure 10. UDEC Model—Stable Roof Conditions for Mining in a Hydrostatic Stress Field

For analytical purposes, a single two-dimensional plane strain model of a rectangular opening featuring a laminated and vertically jointed roof was constructed. The model geometry and material properties are shown in Figure 10. Pre-mining vertical stress was initialized to 11.4 MPa at the mining horizon, representing a nominal depth of 457 m. Pre-mining horizontal stresses were varied from mild tension to compression three times greater than the vertical stress to analyze their influence on roof stability.

Stable conditions were achieved in the model for a hydrostatic stress state, i.e., where horizontal and vertical stresses are equal. As shown in Figure 10, no plastic failure occurred in the roof at this stress level. The destabilizing effect of increasing horizontal stress is illustrated in Figures 11 and 12, which show the extent of roof collapse associated with horizontal stresses two and three times the vertical stress, respectively.
