Ground Control Design Challenges at the El Boleo Copper Project

David Conover, Senior Physicist
Tim Ross, Principal
Agapito Associates, Inc.
Golden, CO

Scott Britton, General Manager - Mining Operations
Baja Mining Corp.
Vancouver, Canada

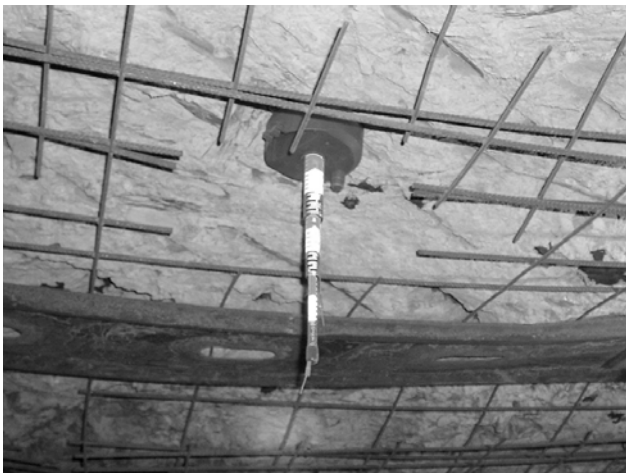
Figure 3. Three-Position Telltale Installation.

The primary geotechnical evaluation for underground mining was based on a test mining program conducted on the Boleo property at the Texcoco Test Mine (Agapito 2006). The Test Mine, shown in Figure 2, consisted of an adit and five side drifts (crosscuts) that were developed to demonstrate the feasibility of development mining and pillar extraction. The furthest crosscut from the portal was used for geotechnical monitoring only. The other four crosscuts were pillared crosscuts, mined sequentially toward the portal. The mine was developed in Manto 3 and was driven partially through old workings. To document the ground behavior at the Test Mine from mining, several geotechnical monitoring stations were installed. The monitoring stations were installed immediately after mining and consisted of two- and three-position wire extensometers (telltales) and floor pins. The telltale anchors were installed at depths of 1.8, 4 and 6 m above the roof anchor. Figure 3 shows a typical installation of a three-position telltale. The floor pins were installed adjacent to the telltales in holes 75 millimeters (mm) below floor level, for protection.

The telltales provided a history of roof movements, between each of the telltale’s anchoring horizons and the mine roof horizon. Significant, but non-critical movements were documented at every telltale location. Measurements between roof bolts and the floor pins showed significant convergence during and after test mining. However, elevation surveys of the floor pins showed no significant floor movement and only minimal horizontal deformations of the floor pins, averaging less than 20 mm.

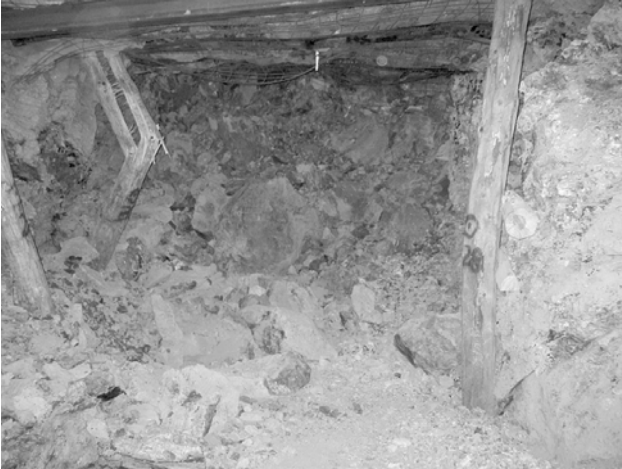
Figure 4. Timber Posts Broken By Pillar Convergence.

Various types of standing support were utilized including timbers, timber cribs, and steel beams supported by timbers or steel legs. Timbers were set on 1-m spacing along most of the rib lines to control rib sloughage. Many of these timbers bowed and broke as a consequence of the significant pillar yielding that occurred during mining (Figure 4). A few timber cribs were built to support

- Based on roof conditions and pull-test results, 19-mm- or 16-mm-diameter roof bolts might perform as well as the tested 22-mm roof bolts. Additionally, the bolt length might be reduced to 1.8 m without sacrificing roof stability.
- The use of steel beams was recommended only where the roof is broken and roof bolts are ineffective. All support legs and other standing supports should incorporate yielding mechanisms to avoid support damage as the opening converges.

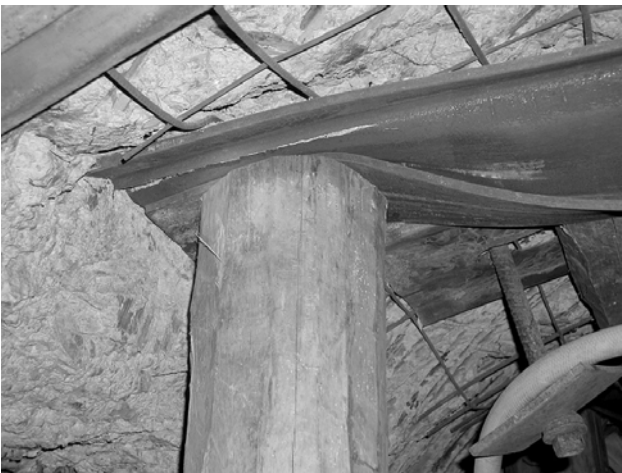
Figure 5. Crushed Steel Beam Resting on Timber Support.

the roof in some historical single-entry mine openings and functioned well, with no reported failures. Steel beams were installed in some locations and were set on either wood timbers or steel legs. Many of the legs did not perform well. The legs were set on the hard conglomerate floor and as the mine opening converged, a significant number of the legs failed and the beam ends crushed (Figure 5).

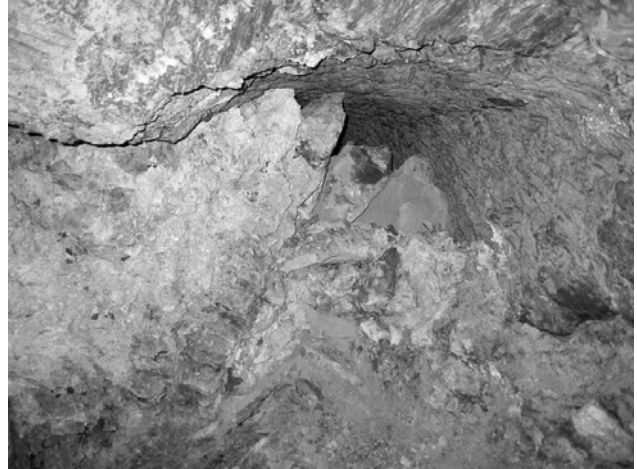
Figure 6. Plastic Deformation of Manto into the Mine Opening.

The pillars of the Test Mine were comprised primarily of clay manto and breccias; however, some sandstones and conglomerates were also present. The sandstone and conglomerate portions of the pillars remained stable during development and pillar mining, whereas the clays and breccias deformed plastically. Once mined and subjected to abutment stresses, the pillars gradually “squeezed” and “flowed” into the excavated openings (Figure 6). Pillar convergence data indicated an average pillar convergence rate of 2 mm per day over the 60-day monitoring period. Because this represents time-dependent plastic yielding, it is doubtful a reasonably sized pillar would fail catastrophically; however, the resulting loss of opening clearance (both vertical and horizontal) and rib stability over time could be problematic to operations if no additional measures are implemented.

The sandstones and conglomerates provided relatively stable ribs; however, the clays and the breccias degraded and failed, sloughing into excavated openings in many locations as a consequence of pillar convergence and loss of moisture from exposure to air. The incidence of failure increased with mining height and time since initial mining. At the completion of test

mining, almost all of the ribs were experiencing some degree of disintegration, and timbers and lagging were being used to minimize the amount of rib material that sloughed into the opening.

- Rib support will be required in many locations; however, use of timbers is problematic. A possible solution is the use of fiberglass bolts and plates, provided that they are compatible with the ore beneficiation process. To contain sloughage, mesh could be installed beneath bolts or behind standing supports.

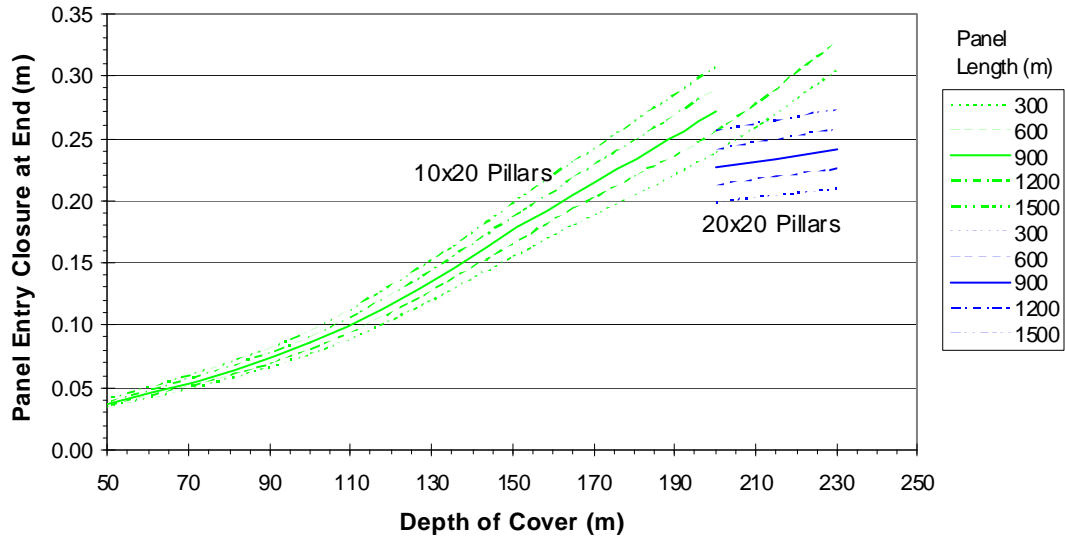
Figure 10. Entry Closure for 10- and 20-m Pillars in Mantos 1 and 3.

For Manto 3 and Manto 1, modeled convergence generally increased linearly, with cover depth, up to the maximum expected depth of 230 m. The models evaluated both 10- by 20- and 20- by 20-m sub-main pillar sizes at depths of 100, 165, 200 and 230 m. Panel length also affects the total closure, but only slightly, through additional time-dependent (creep) deformations. Figure 10 shows the calculated entry closure for the two pillar sizes. Total entry closure and closure rate at the sub-mains comparison point were greater for the 10-m cases than for the 20-m designs. At 200 m depth, the total closure is approaching the 340-mm allowable limit and the 10-m pillars are considered marginally stable. The lower closure rate of the 20-m pillars provides a margin of safety against exceeding the closure limit. Based on the modeling results, the 10-m-wide sub-main pillar was considered adequate for cover depths of up to at least 200 m. For depths over 200 m, a 20-m-wide sub-main pillar was recommended.

- The 10- and 20-m pillar width alternatives appear feasible for Mantos 1 and 3 up to the maximum cover depths. Preliminary depth limits were developed for Mantos 2 and 4; however, additional data and modeling are required to confirm adequate pillar sizes.
