GEOLOGIC CONTROLS ON COMPLEX SLOPE DISPLACEMENT AT THE PITCH RECLAMATION PROJECT

James A. Cremeens, Senior Engineer

Agapito Associates, Inc., 715 Horizon Drive, Suite 340, Grand Junction, CO 81506

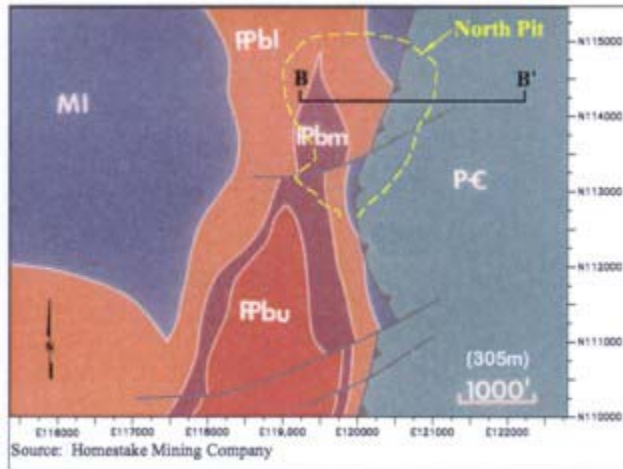
(Figure 2A)

Figure 2. (A) Generalized geologic map of the North Pit area, and (B) generalized east–west, pre-mining geologic cross section through the North Pit area.

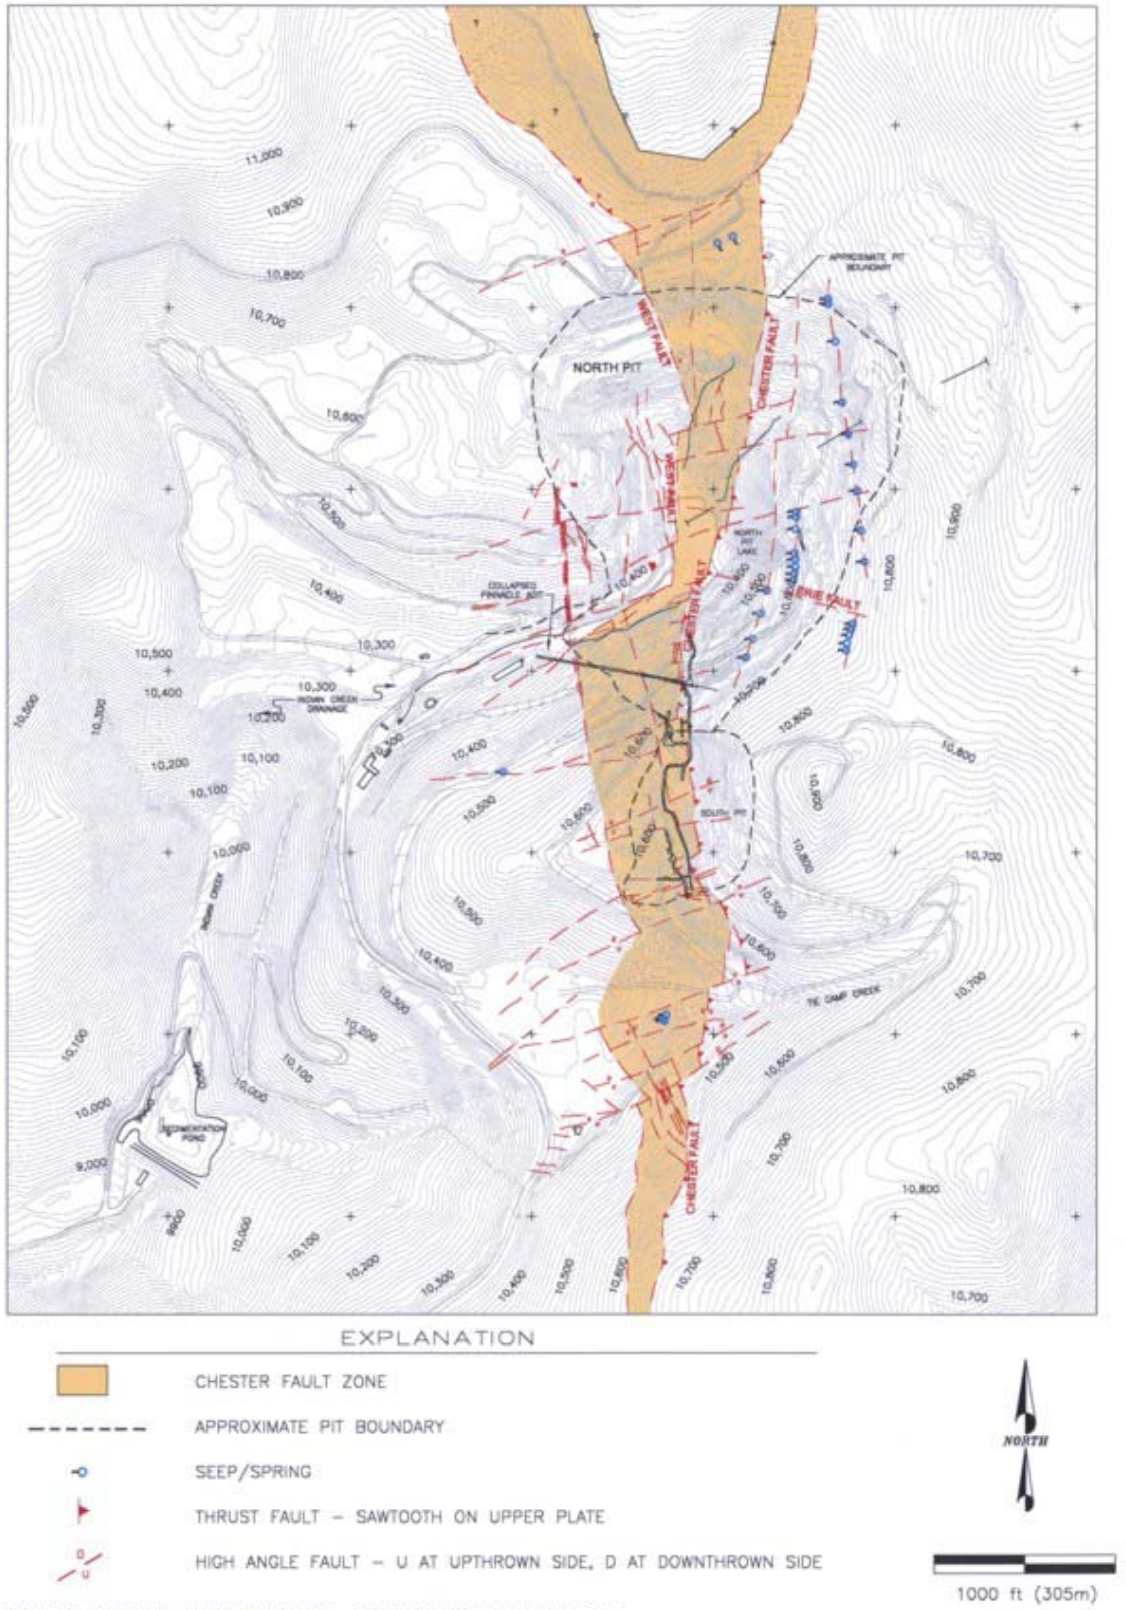
Figure 3. Structural geology map of the Pitch site.

The Upper Block is comprised of weathered pegmatite and schist and is relatively free draining. At the Middle Block, the north–south oriented, high-angled faults create low-permeability barriers to ground-water flow. This is evidenced by north–south oriented linear patterns of springs, as shown on Figure 3. It appears that the linearity of these springs reflects the trace of high-angled, in-dipping faults. Movement along the northeast–southwest oriented transverse faults has resulted in additional barriers to ground-water flow in the north–south direction. The combination of north–south trending faults, coupled with the northeast–southwest trending faults, resulted in a compartmentalized ground-water system.
